Project Number 1180828C

Subject: EZ 1" Standard Standing Seam Clamp with L-Foot Laboratory Load Testing
Part #K50200-001 Attached to 24ga EZ Lock by Taylor Systems

APPLIED MATERIALS & ENGINEERING, INC.

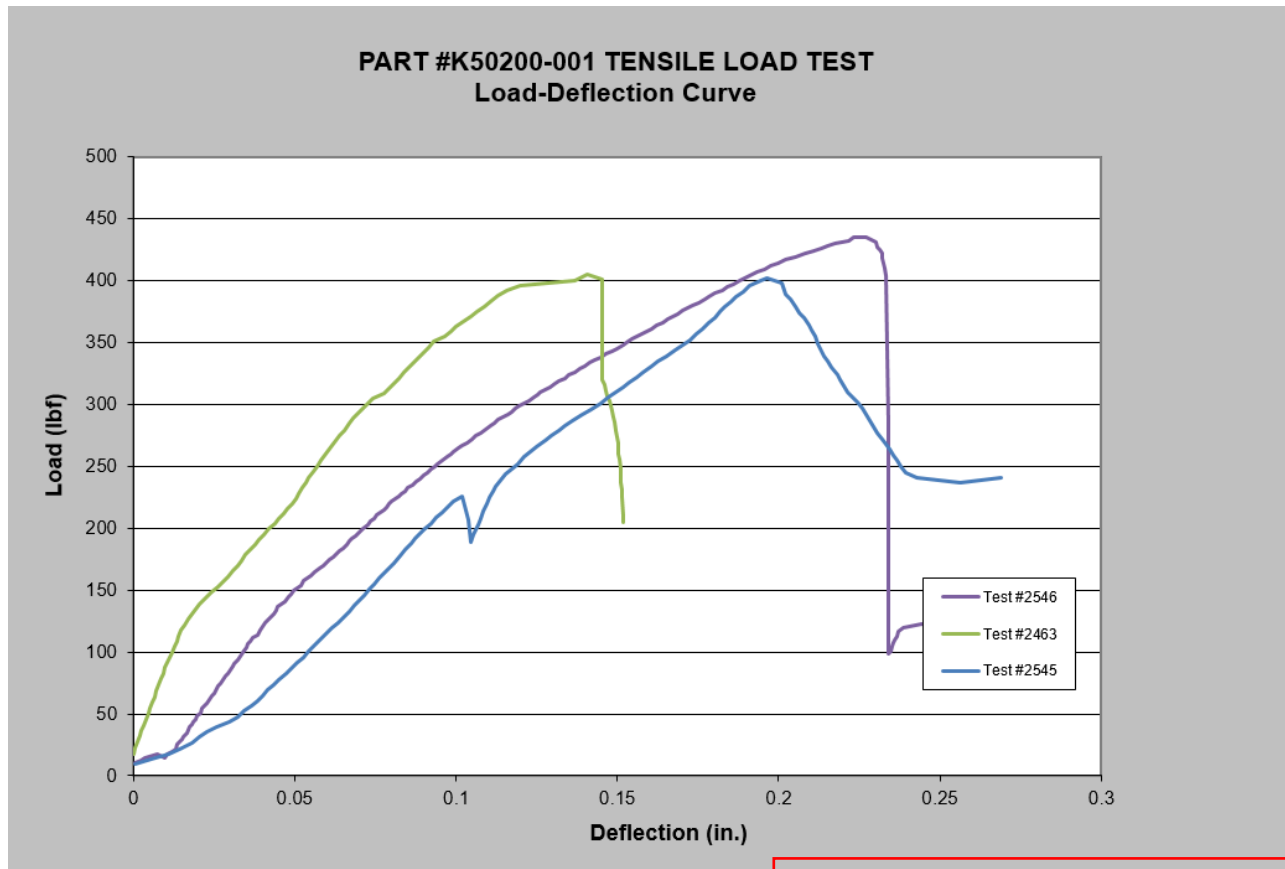
FIGURE 1

Based on the above testing, the average maximum uplift load of the EZ 1" Standard Standing Seam Clamp with L-Foot attached to a 24ga EZ Lock roofing sample by Taylor Systems was determined to be 414 lbf. Detailed results are provided in Table I and Figure 1. Test setup and mode of failure are provided in Appendix B, Figure B1.

TEST NUMBER	MAXIMUM TENSILE LOAD (lbf)	DEFLECTION AT MAXIMUM LOAD (in.)	MODE OF FAILURE
2546	435	0.2	Seam Clamp Slippage
2463	405	0.1	
2545	402	0.2	
AVERAGE	414	0.2	..

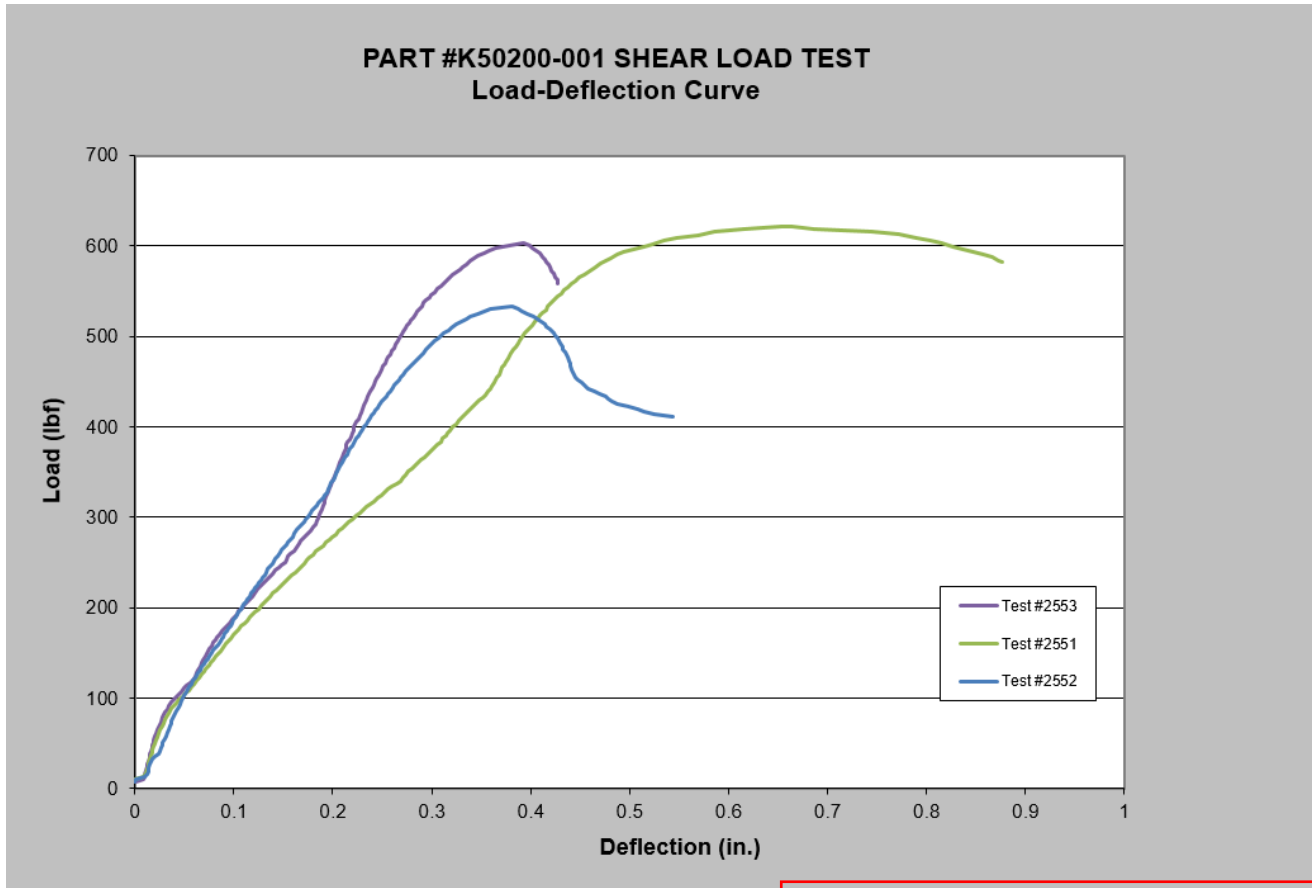
FIGURE 2

Based on the above testing, the average maximum shear load of the EZ 1" Standard Standing Seam Clamp with L-Foot attached to a 24ga EZ Lock roofing sample by Taylor Systems was determined to be 586 lbf. Detailed results are provided in Table II and Figure 2. Test setup and mode of failure are provided in Appendix B, Figure B2.

TEST NUMBER	MAXIMUM SHEAR LOAD (lbf)	DEFLECTION AT MAXIMUM LOAD (in.)	MODE OF FAILURE
2551	622	0.7	Seam Clamp Slippage
2552	533	0.4	
2553	603	0.4	
AVERAGE	586	0.5	..

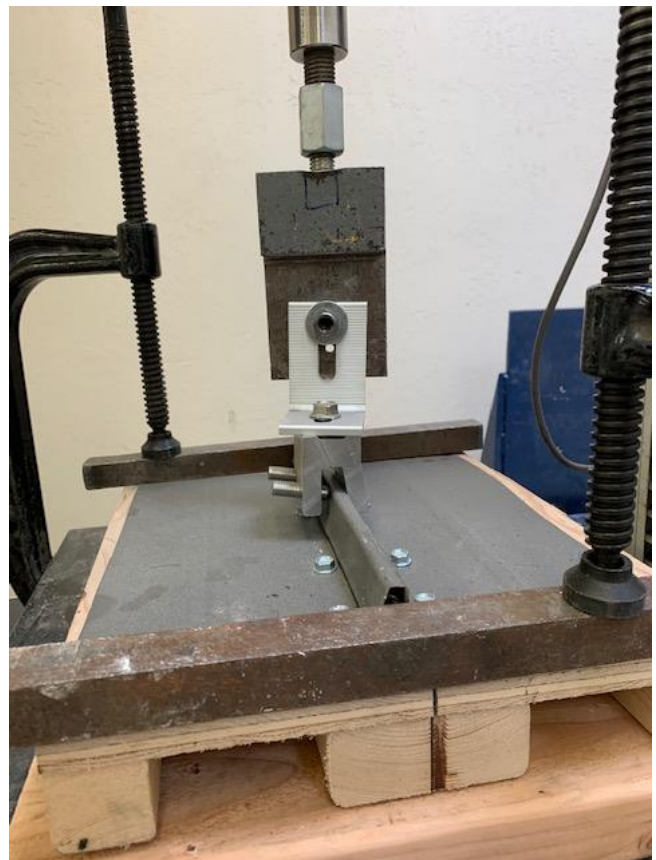
Figure B1b. Typical Failure Mode

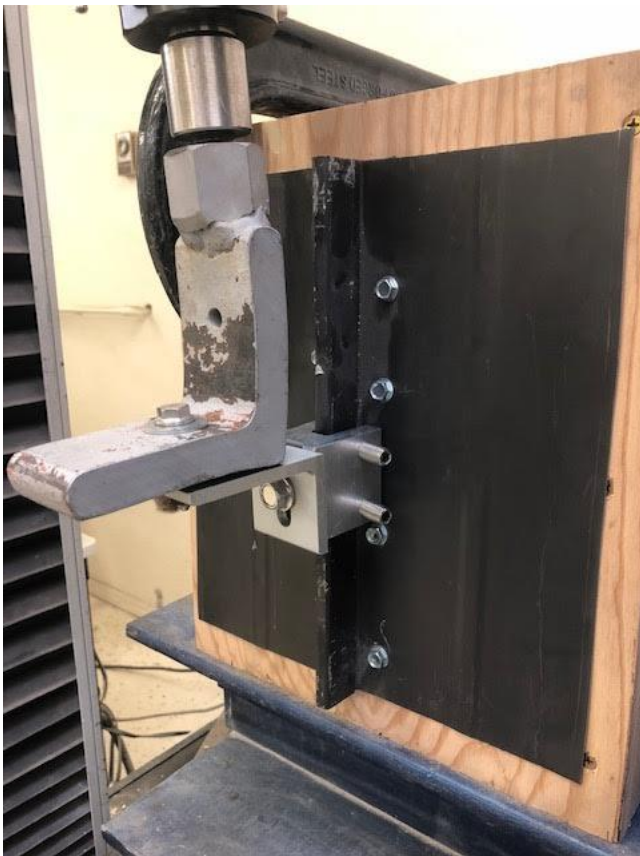
A total of three tests were conducted for lateral (shear) load capacity on October 23, 2018 using a United Universal testing machine. Samples were rigidly attached to the testing machine and a shear load (parallel to the rafter and roofing sample seam) was applied to each clamp. The samples were loaded in a downward direction at a constant rate of axial deformation of 0.10 in. /min. without shock until failure occurred; displacement at maximum load was recorded.

LATERAL (SHEAR) LOAD TEST SETUP

Figure B2a. Test Setup

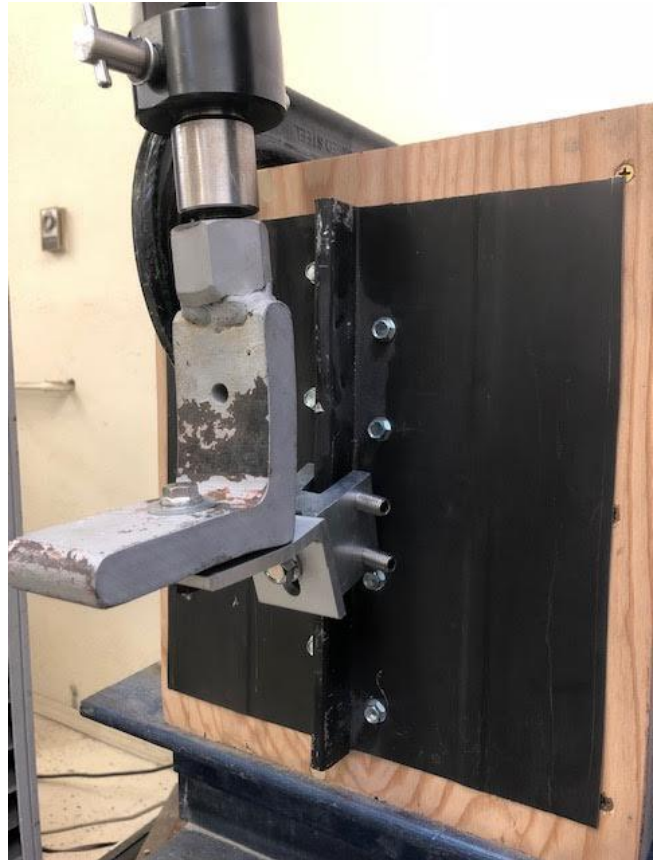
Figure B2b. Typical Failure Mode
