Project Number 1180828C

**Subject:** EZ 2" Standard Standing Seam Clamp with L-Foot Laboratory Load Testing  
Part #K50210-001 Attached to 24ga MS-200 by Taylor Systems

**APPLIED MATERIALS & ENGINEERING, INC.**

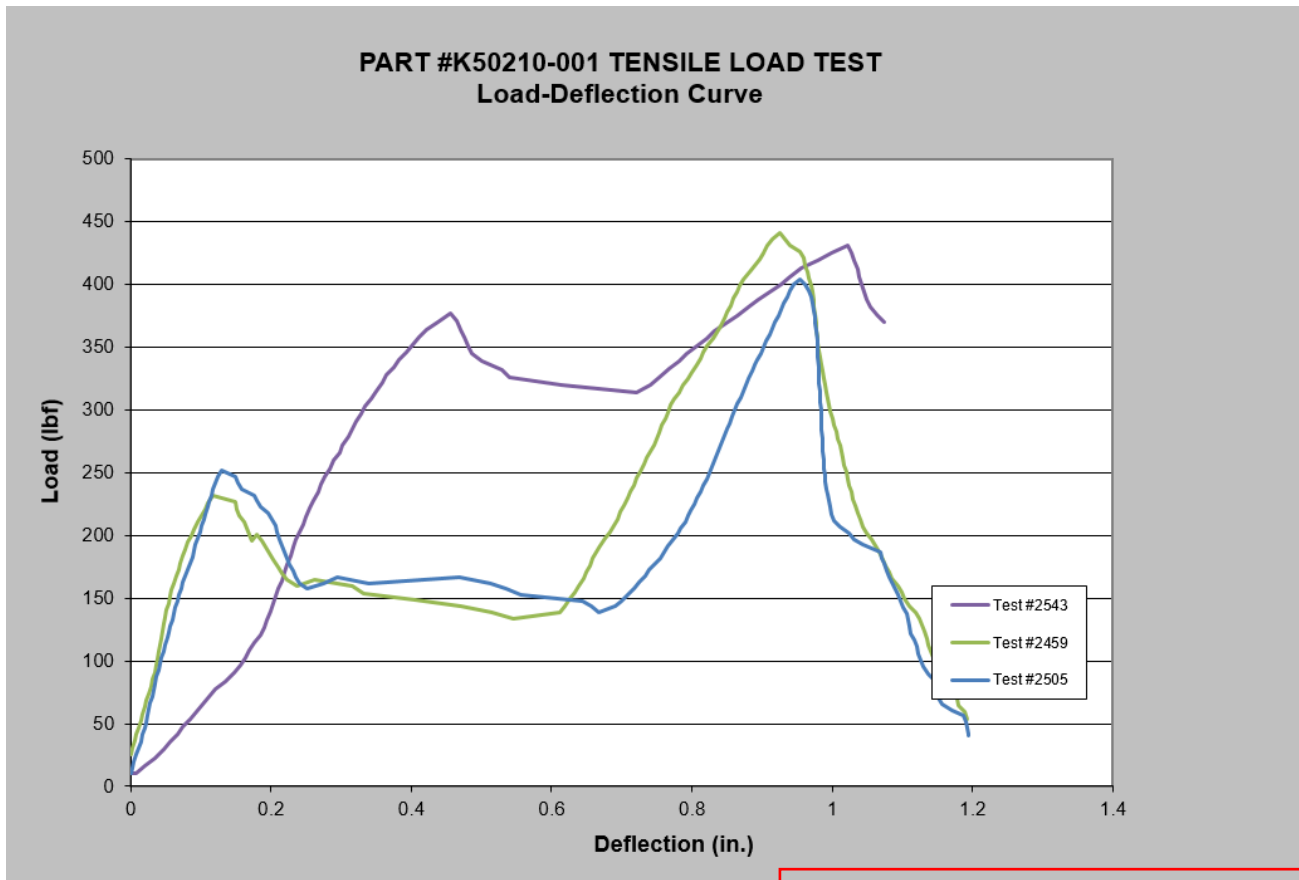
**FIGURE 1**

TEST NUMBER	MAXIMUM TENSILE LOAD (lbf)	DEFLECTION AT MAXIMUM LOAD (in.)	MODE OF FAILURE
2459	441	0.9	Seam Clamp Slippage
2505	404	1.0	
2543	431	1.0	
<b>AVERAGE</b>	<b>425</b>	<b>1.0</b>	<b>..</b>

Based on the above testing, the average maximum uplift load of the EZ 2" Standard Standing Seam Clamp with L-Foot attached to a 24ga MS-200 roofing sample by Taylor Systems was determined to be 425 lbf. Detailed results are provided in Table I and Figure 1. Test setup and mode of failure are provided in Appendix B, Figure B1.

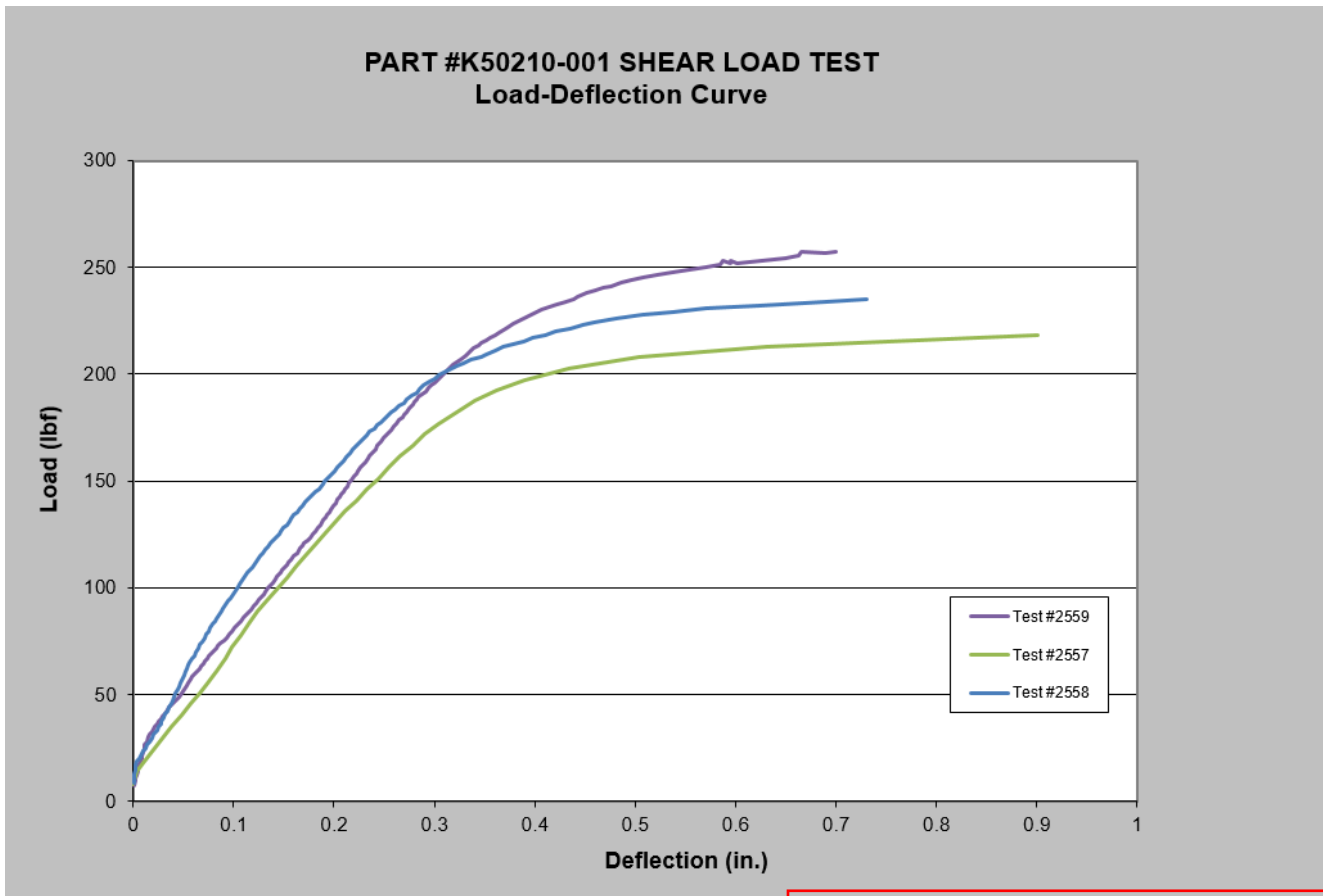
**FIGURE 2**

TEST NUMBER	MAXIMUM SHEAR LOAD (lbf)	DEFLECTION AT MAXIMUM LOAD (in.)	MODE OF FAILURE
2557	218	0.9	Seam Clamp Slippage
2558	235	0.7	
2559	257	0.7	
<b>AVERAGE</b>	<b>237</b>	<b>0.8</b>	..

Based on the above testing, the average maximum shear load of the EZ 2" Standard Standing Seam Clamp with L-Foot attached to a 24Ga MS-200 roofing sample by Taylor Systems was determined to be 237 lbf. Detailed results are provided in Table II and Figure 2. Test setup and mode of failure are provided in Appendix B, Figure B2.

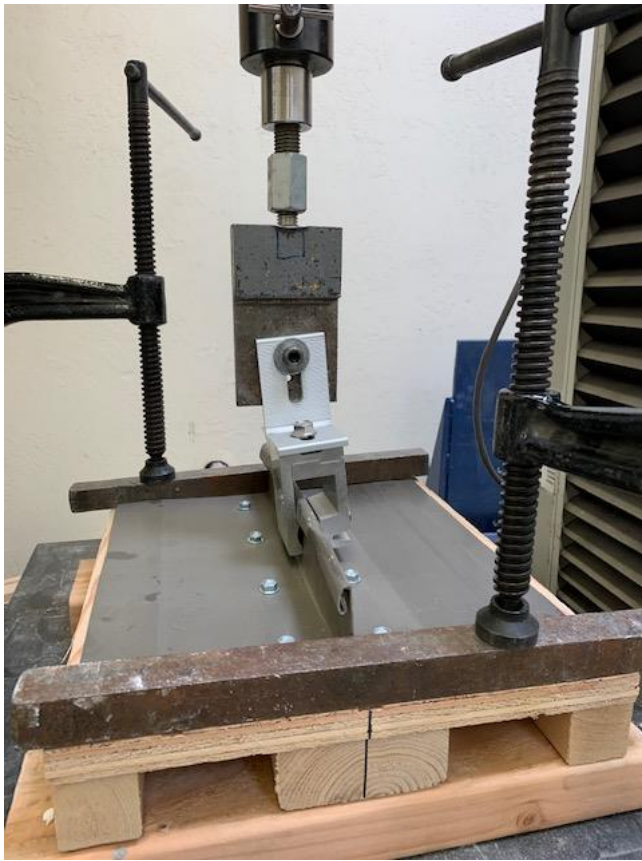
**Figure B1a.** Test Setup

A total of three tests were conducted for tensile (uplift) load capacity on October 29, 2018 using a United Universal testing machine. Samples were rigidly attached to the testing machine and an uplift (tensile) load was applied to each clamp. The samples were loaded in tension at a constant rate of axial deformation of 0.10 in. /min. without shock until failure occurred; deflection at maximum load was recorded.

**TENSILE LOAD TEST SETUP**

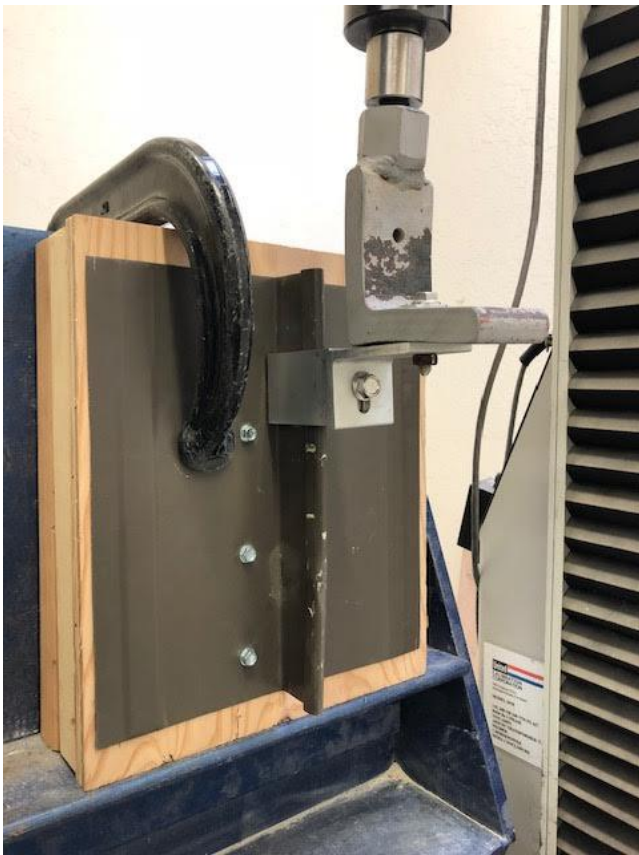
**Figure B2a. Test Setup**

A total of three tests were conducted for lateral (shear) load capacity on October 30, 2018 using a United Universal testing machine. Samples were rigidly attached to the testing machine and a shear load (parallel to the rafter and roofing sample seam) was applied to each clamp. The samples were loaded in a downward direction at a constant rate of axial deformation of 0.10 in. /min. without shock until failure occurred; displacement at maximum load was recorded.

**LATERAL (SHEAR) LOAD TEST SETUP**
